**ADVISORY LEVEL: Mandatory**

**DESCRIPTION: Bell Gear Drive Plate Cracks**

**ENGINE TYPE: R2800 / R3600**

**INSPECTION FREQUENCY: 25 Hours**

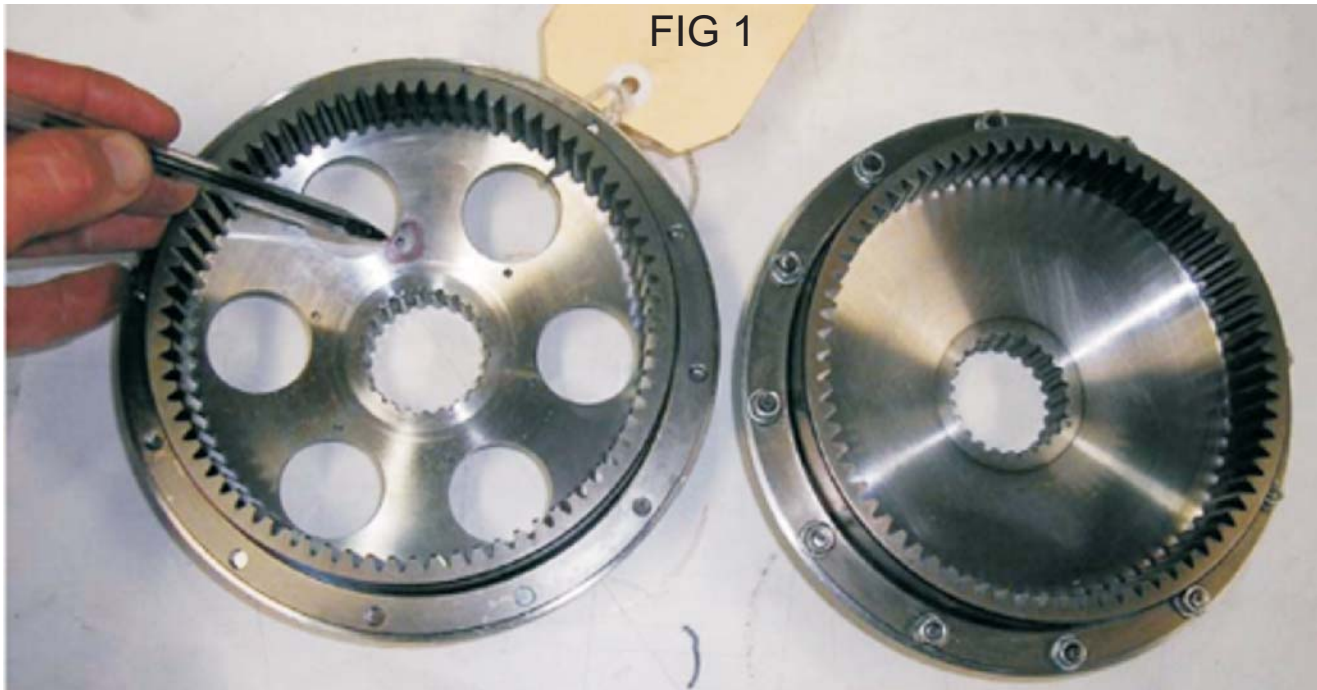
FIG 1: depicts two "Bell Gear" drive plates. The one on the left is the early version and on the right the later version which supersedes the previous.

Owners with the early version should check for cracks developing in the vicinity of the small safety wire hole as indicated by the pen. In isolated cases cracks can develop between this small safety hole and the large hole. In extreme cases the crack can bridge across the large holes severing one of the six main webs. A magnifying glass is recommended to conduct a proper visual inspection.

Rotec recommend inspection of the bell gear and PSRU on all engines, irrespective of the type of carrier plate, as such inspections provide a visual representation on the health of the engine, oil distribution and wear patterns.

On detecting anything unusual on the bell gear or PSRU please contact the Rotec Factory.

Remove the nose bowl/cone to inspect the Bell Gear and PSRU. Removal does not require dismantling the engine. It does not require removing the propeller flange and the propeller does not need to be removed.
