## ADVISORY LEVEL: Mandatory

DESCRIPTION: Broken Cylinder Base Studs

ENGINE TYPE: R2800 / R3600

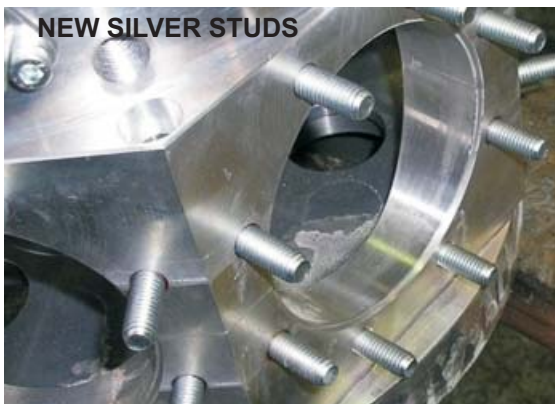
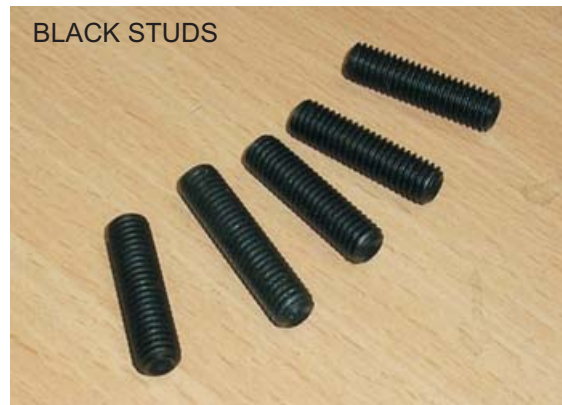
Several batches of earlier studs employed by Rotec have exhibited mechanical properties that were too brittle for the application. Consequently in operation some of these studs have failed under the tensile forces exerted by engine combustion pressures.

The **studs** in question are identified as being black in colour.

Engines since have been fitted with silver studs without one reported instance of failure.

For engines with black studs please conduct an immediate visual inspection for any missing or broken studs. If none are found inspect for broken studs every 25 hours (at each oil change)

For engines found to have missing or broken studs please contact the Rotec Factory for options to correct the problem.

**Do NOT attempt to drill out any broken studs as this will not work and may cause irreparable damage to the crankcase.**
